Manhole Inspection Summary

Manhole # S55G__029MH

Insp Date: **4/22/08 9:11 AM**

Location Address: **3701 gough street**

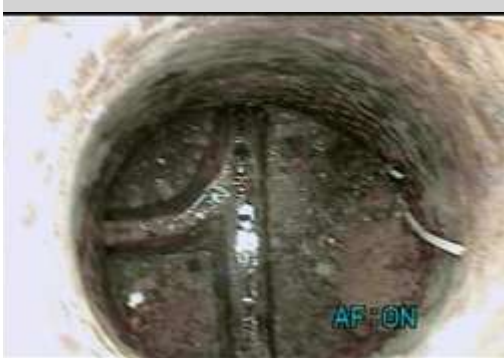
Defect 1

Count: **4** Missing: **3** ☐ Corroded

steps missing

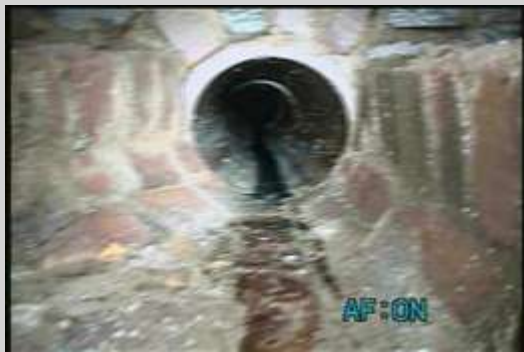
12 O'Clock Outflow

8 in. Circular Gravity Sewer
Pipe Out @ 12 O'Clock

Invert Depth: **8.20** (ft.) Flow Characteristics: **Slow**

Infiltration: **None** Pipe Seal Cond: **Unknown**

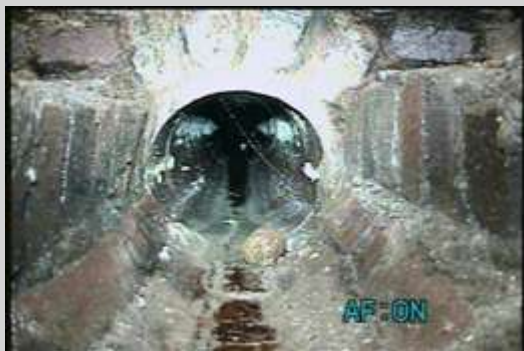
6 O'Clock Inflow

8 in. Circular Gravity Sewer
Pipe In @ 6 O'Clock

Invert Depth: **8.00** (ft.) Flow Characteristics: **Slow**

Infiltration: **None** Pipe Seal Cond: **Unknown**

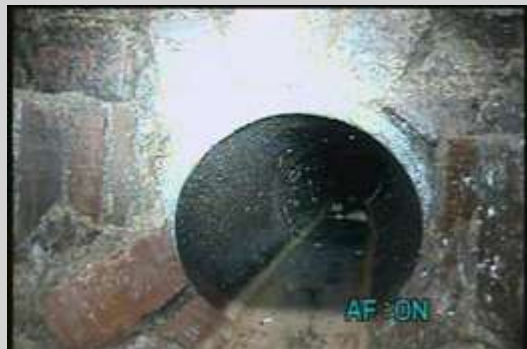
9 O'Clock Inflow

8 in. Circular Gravity Sewer

Pipe In @ 9 O'Clock

Invert Depth: **8.00** (ft.) Flow Characteristics: **Slow**

Infiltration: **None** Pipe Seal Cond: **Unknown**
